EVALUATION OF STRUCTURAL LAYERS IN FLEXIBLE
PAVEMENT

ARMY ENGINEER WATERWAYS EXPERIMENT STATION

MISCELLANEOUS PAPER S-73-26

May 1973

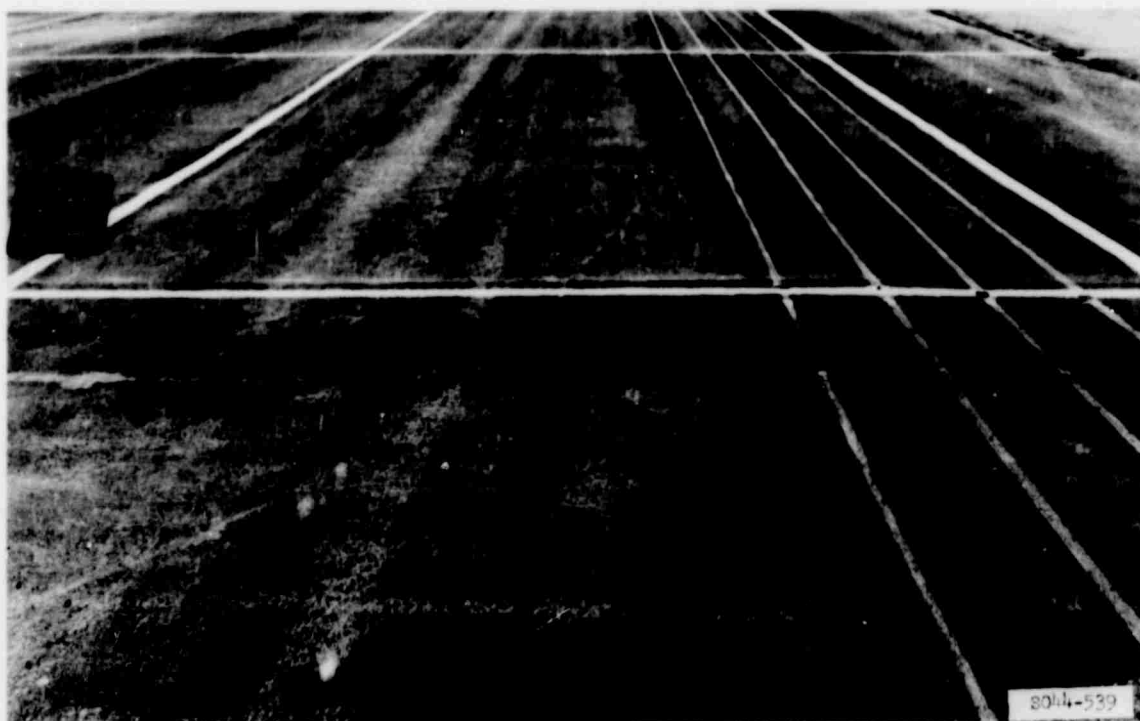
2. Item 1 (lime-stabilized lean clay subbase). A general view of item 1 prior to traffic is shown in photo B1. Initial cracking, which consisted of small hairline cracks approximately 2 ft long, was observed after 64 coverages. These cracks occurred at longitudinal paving-lane construction joints about 3 ft inside both edges of the traffic lane. During the remainder of traffic, these cracks tended to open and close as the test cart traversed the 200-in.-wide lane. After 99 coverages, the construction-joint cracks were about 20 ft in length and had a maximum width of 1/16 in. Intermittent hairline cracks located 1-1/2 ft either side of the center line of the traffic lane were also observed, throughout the length of the test item, at this time. After 198 coverages, this item was considered failed (photo B2) because of the severe cracking in the center 3 ft of the lane and along the construction joints (photo B3). The cracks at these locations went completely through the pavement and, in some instances, were about 1/2 in. wide. In addition to these cracks, alligator cracking was observed over the

Photo B1. Item 1, lane 1, prior to traffic

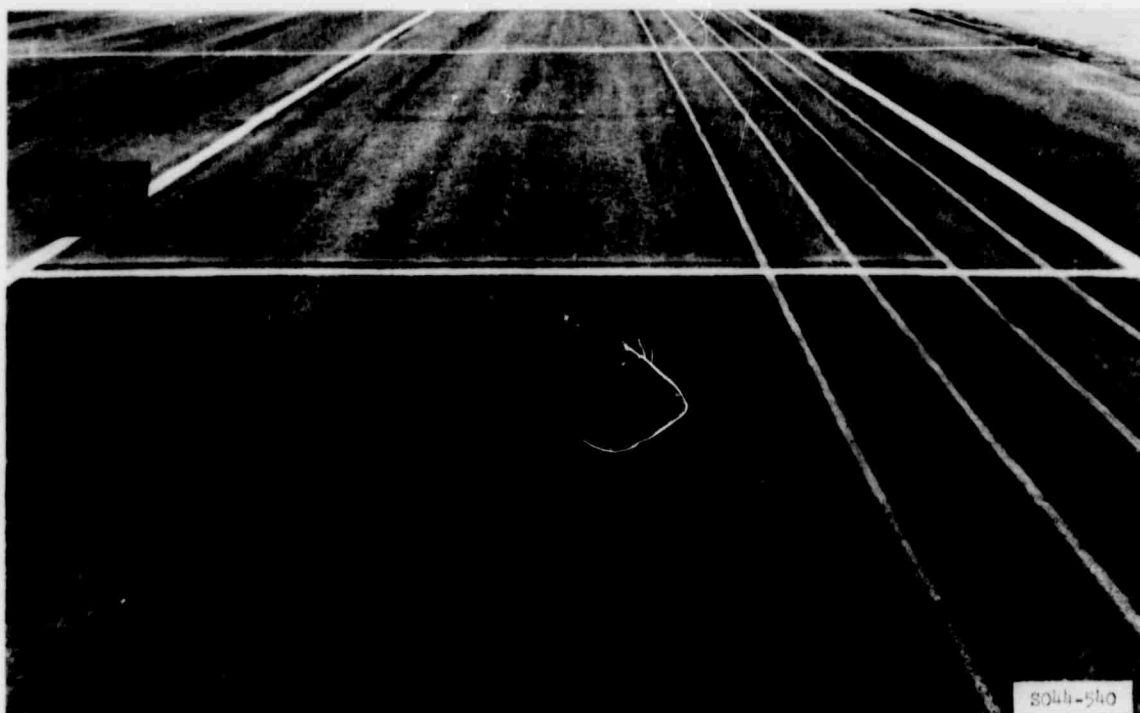
3. Item 2 (cement-stabilized lean clay subbase). An overall view of item 2 prior to traffic is shown in photo B4. Distress of the pavement was first noticed at 172 coverages of traffic. This distress was a continuation of the construction-joint cracking that originated in item 1. As traffic was continued, the cracks on either side of the 10-ft-wide paving lane became longer. After 201 coverages, they were approximately 1/32 in. wide and extended the length of the item. A close-up of this type of pavement cracking is shown in photo B5. At 268 coverages, hairline cracks were noticed at the transition of items 2 and 3. As traffic continued, these cracks rapidly became wider. After 783 coverages, an area between 2 to 3 ft either side of this transition had cracked completely through the pavement.

Photo B4. Item 2, lane 1, prior to traffic

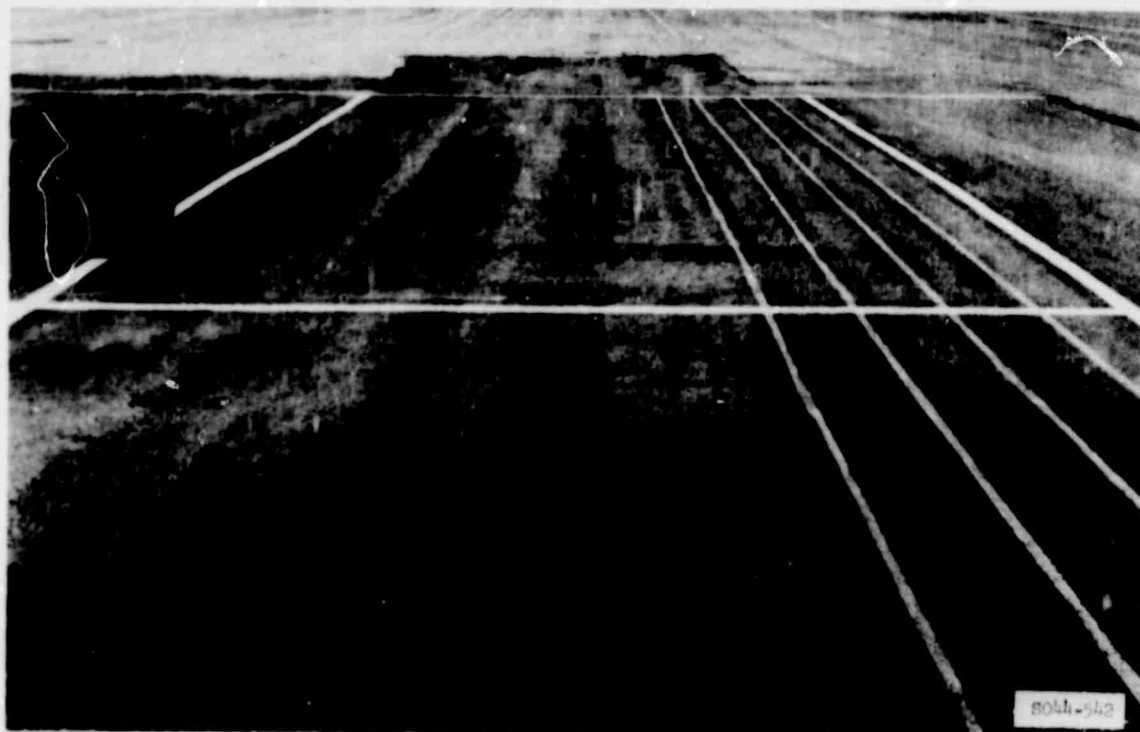
8044-562

Very little distress was observed on the pavement surface of item 4 during the 360-kip, 12-wheel-assembly traffic. A general view of this item prior to traffic is shown in photo B12. At about 1515 coverages, a very small hairline crack in the construction joint located about 3 ft south of the north edge of the traffic lane and three small cracks perpendicular to this crack were noted. The item was rated as in excellent condition at this time and was in the general condition shown in photo B13. After 5046 coverages, small hairline cracks were detected about two wheel-print widths from the north side of the traffic lane. Three 1/32- to 1/16-in.-wide cracks were perpendicular to these hairline cracks and extended to the edge of the traffic lane. Traffic was continued to 10,406 coverages, and the only change in the condition of the pavement was development of several small cracks extending out from the cracked construction joint, as shown in photo B14. Indications were that a large number of coverages would be required to produce failure; therefore, traffic was discontinued.

Photo B12. Item 4, lane 1, prior to traffic

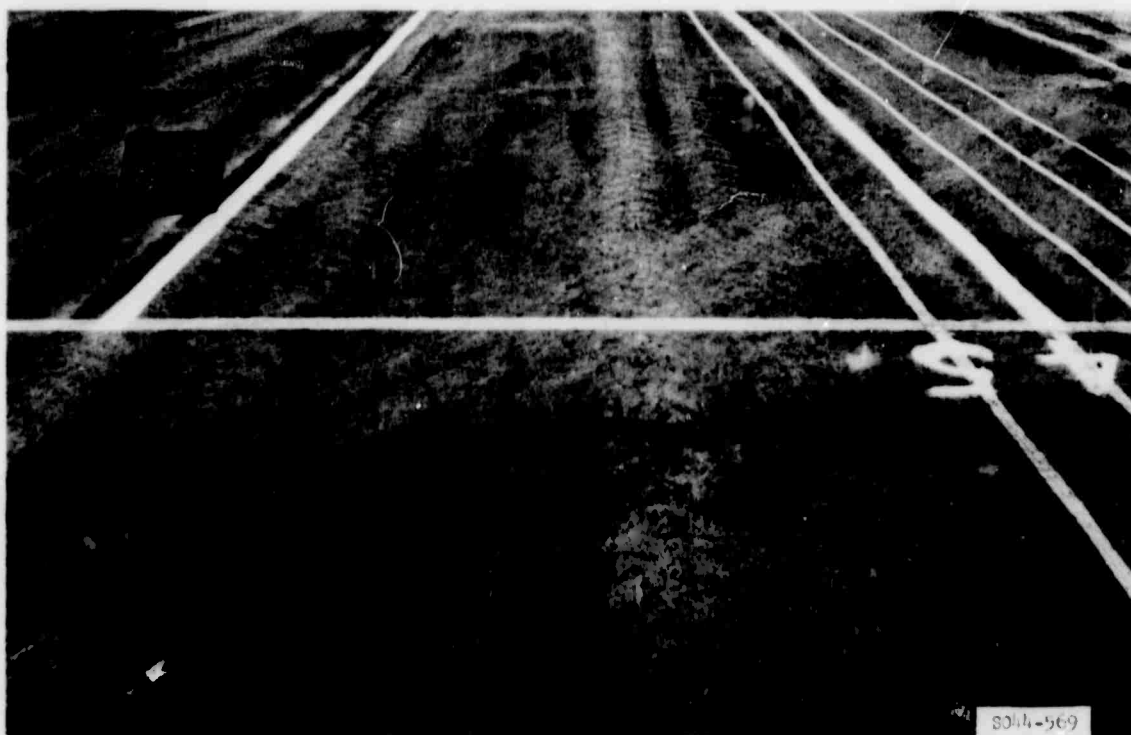
Photo B15. Item 1, lane 2, prior to traffic

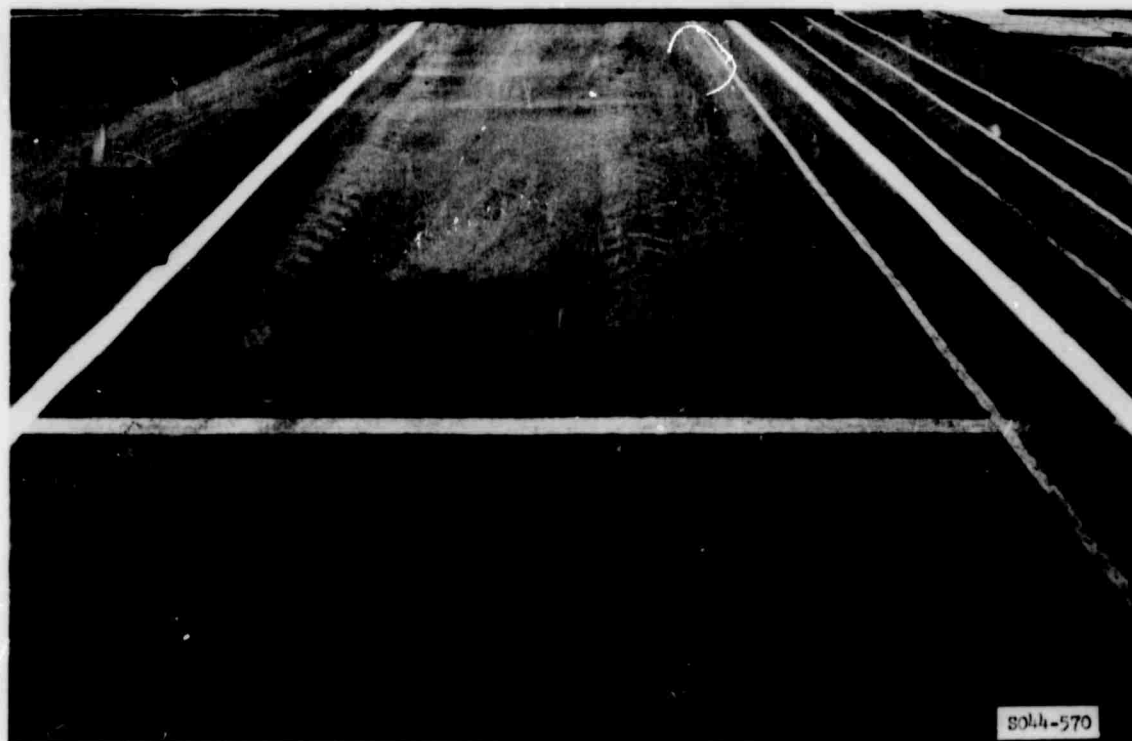
Photo B18. Item 2, lane 2, prior to traffic

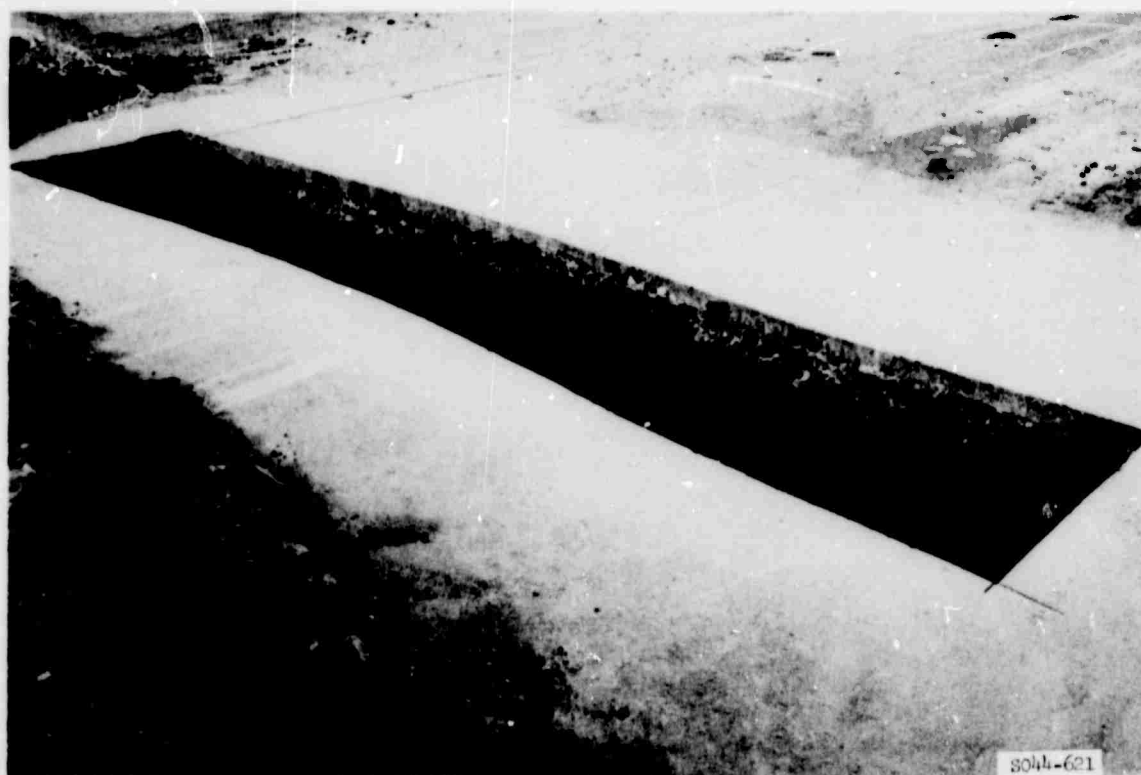
Photo B21. Test trench across item 1, lanes 2 and 3

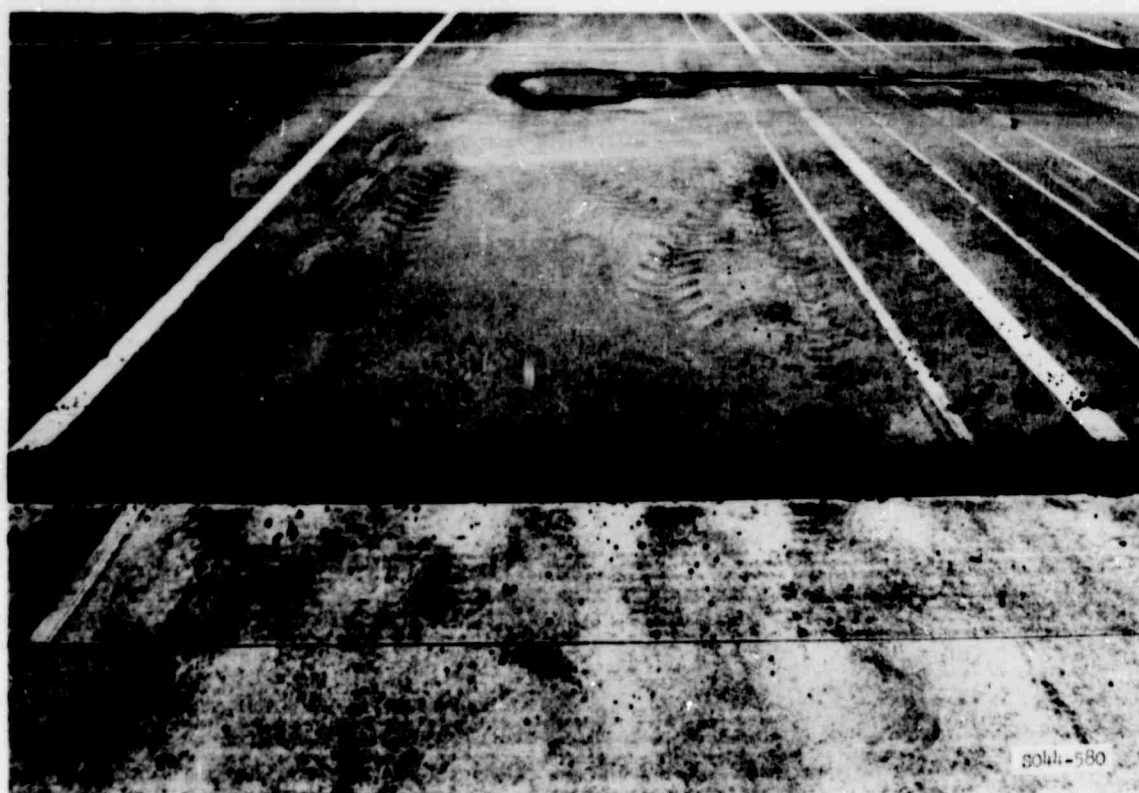
Photo B22. Item 3, lane 2, prior to traffic

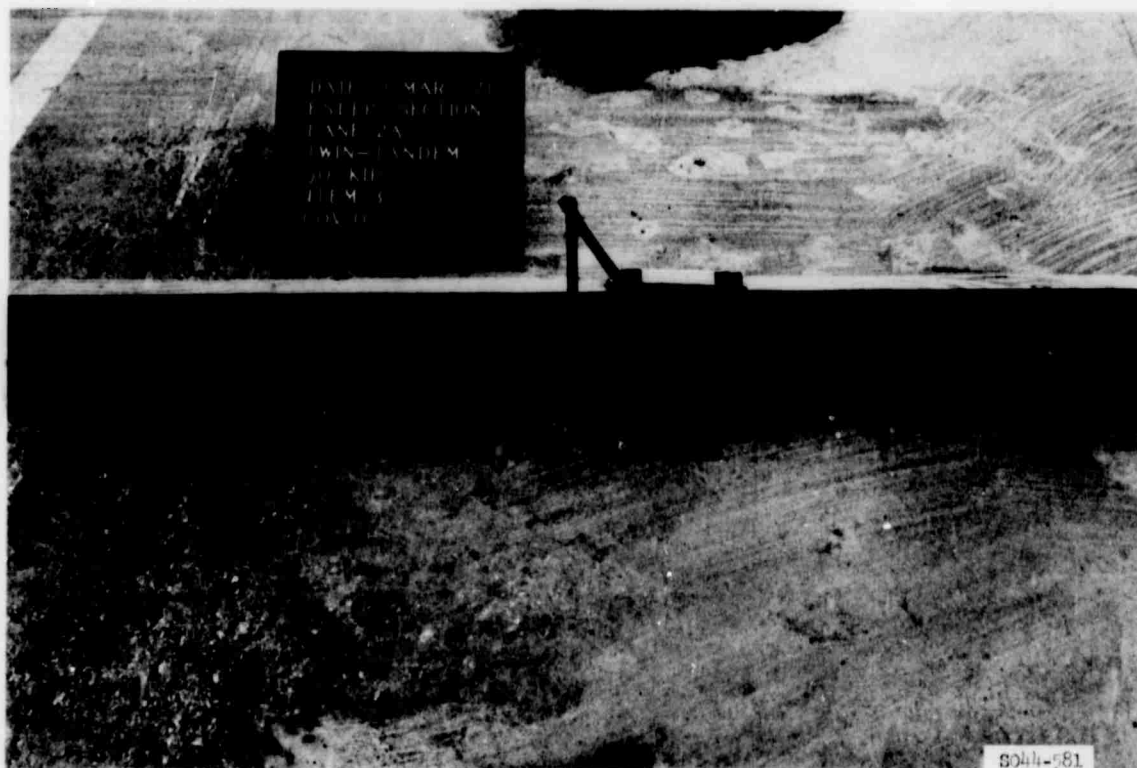
Photo B23. Deformation in item 3, lane 2, prior to 200-kip, twin-tandem-assembly traffic

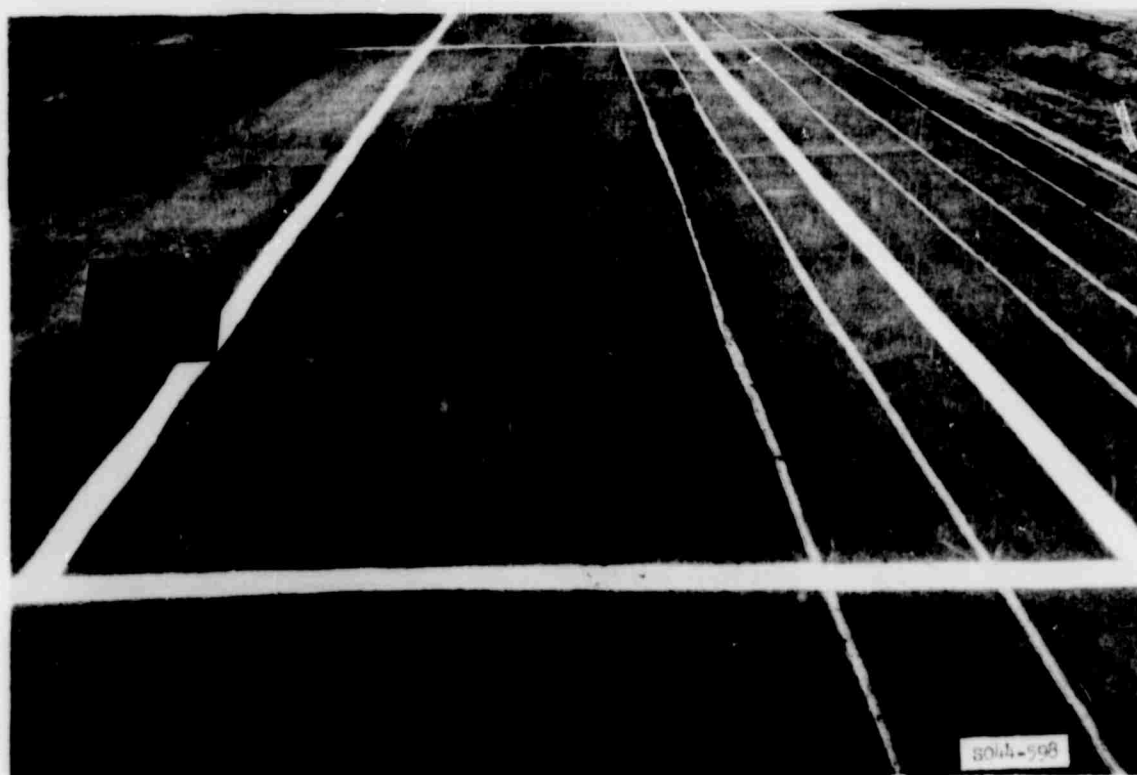
Photo B28. Item 1, lane 3, prior to traffic

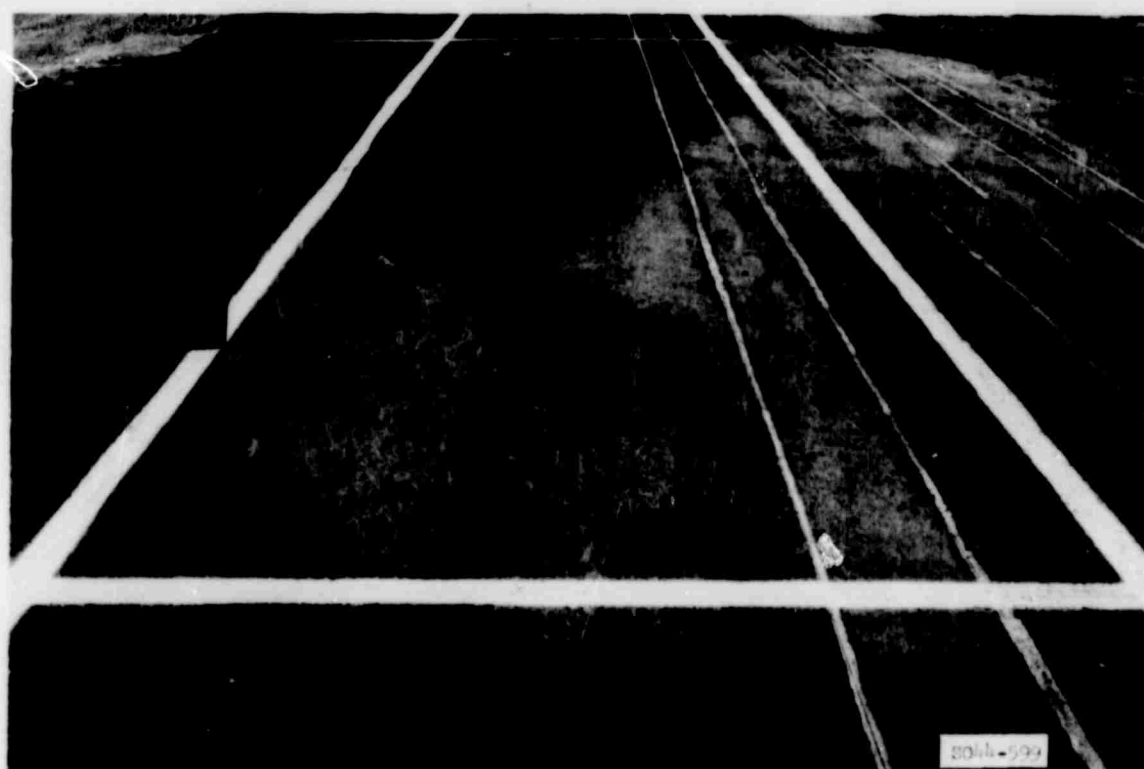
Photo B30. Item 2, lane 3, prior to traffic

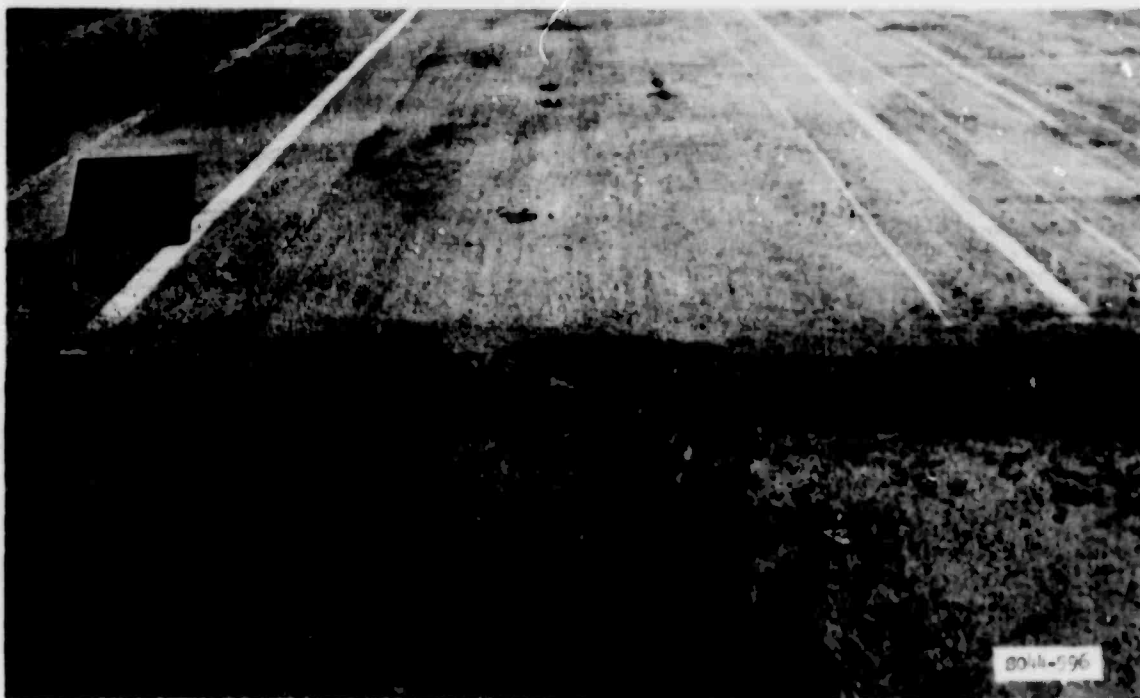
Photo B38. General view of item 4, lane 1, after 10,406 coverages of the 360-kip, 12-wheel assembly and prior to trafficking with the 75-kip, single-wheel assembly

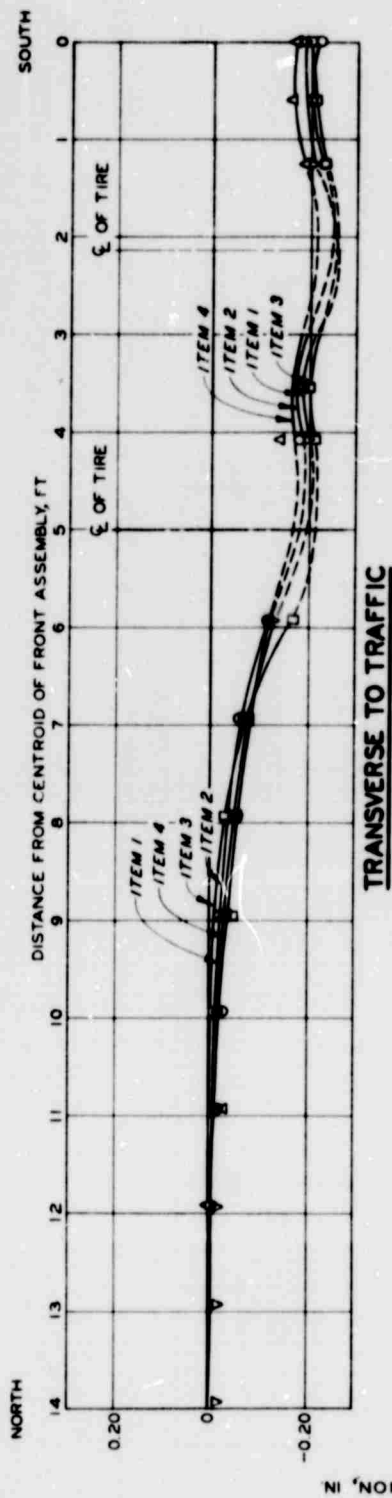
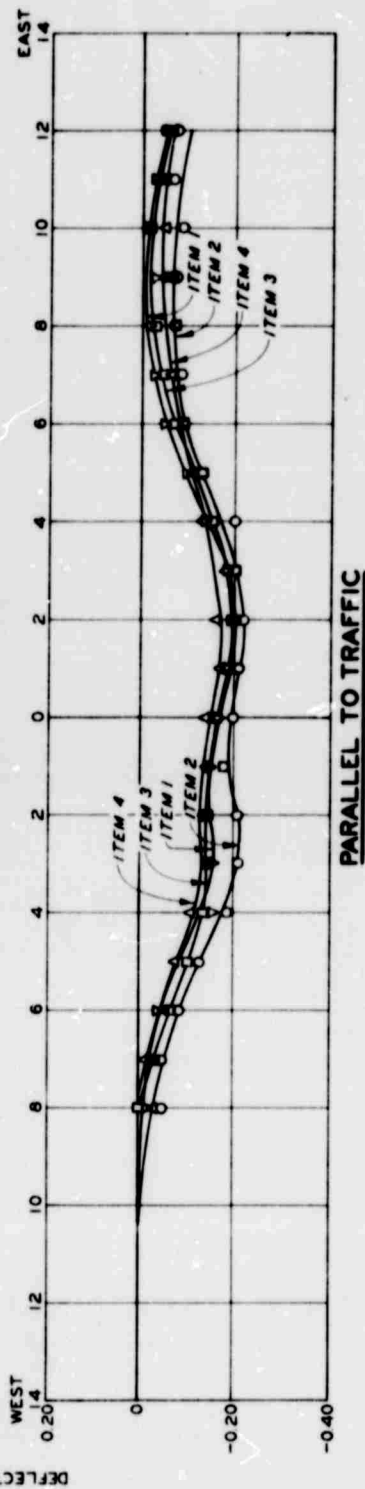
11. Plots of the total deflection measurements taken prior to test traffic and at or near failure of each item are shown in plates B2 and B3. From these data, it can be seen that the total deflection in items 1-3 prior to traffic was about 0.25 in. and in item 4 about 0.21 in. The maximum total deflection measured at failure in the three failed items ranged from 0.30 to 0.41 in. The plots also indicate that the maximum deflection measured in item 4 was about 0.20 in., after 10,406 coverages of traffic, which was about the same or slightly less than the initial deflection. The readings taken after the load was removed indicated that 95 percent or more of the deflection measured was elastic. The deflections measured during the traffic period, tabulated in table 3 of the main text, showed that as traffic was applied deflection increased in items 1-3 and remained about the same in item 4. This determination indicates that a continued increase in deflection is a sign of a pavement structure approaching failure.

TOTAL DEFLECTION
LANE 1
360-KIP 12-WHEEL ASSEMBLY
O COVERAGES
